AIRCRAFT ACCIDENT REPORT

UNCONTROLLED DESCENT AND COLLISION WITH TERRAIN
USAIR FLIGHT 427
BOEING 737-300, N513AU
NEAR ALIQUIPPA, PENNSYLVANIA
SEPTEMBER 8, 1994

**NTSB/AAR-99/01
PB99-910401
Notation 6472A
Adopted March 24, 1999**

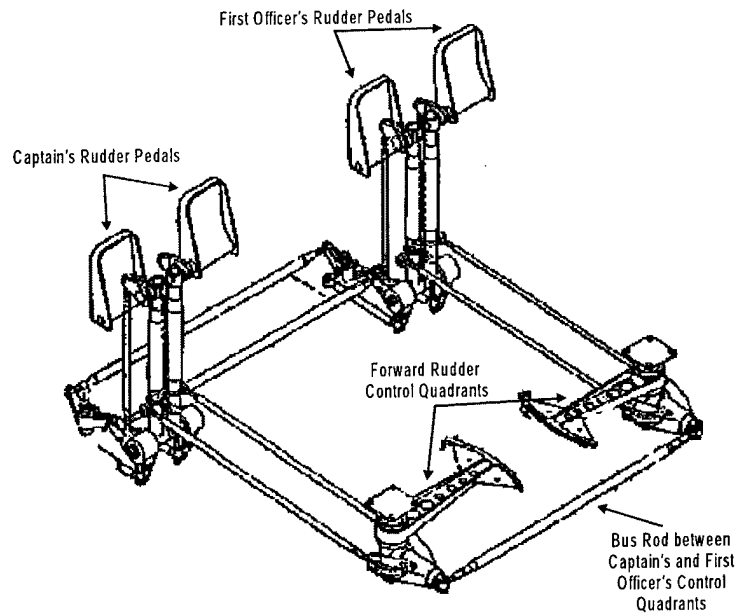
Figure 12. Rudder pedal assemblies as installed on the USAir flight 427 airplane.

The accident airplane's rudder pedal assemblies from both flight crew positions were removed from the wreckage. Both rudder pedal assemblies were fragmented and heavily distorted. The rudder pedal assembly from the first officer's position exhibited postimpact fire damage. The left rudder pedal pivot lugs on both rudder pedal assemblies were fractured near their respective support tubes.¹²⁶ Figure 12 shows a diagram of the rudder pedal assemblies as installed on the accident airplane.

direction. The right rudder pedal pivot lugs on both assemblies were bent but remained attached to their support tubes. With the support tubes positioned vertically, the right rudder pedal pivot lug at the captain's position was bent forward and downward, but the right rudder pedal pivot lug at the first officer's position was bent forward and upward.

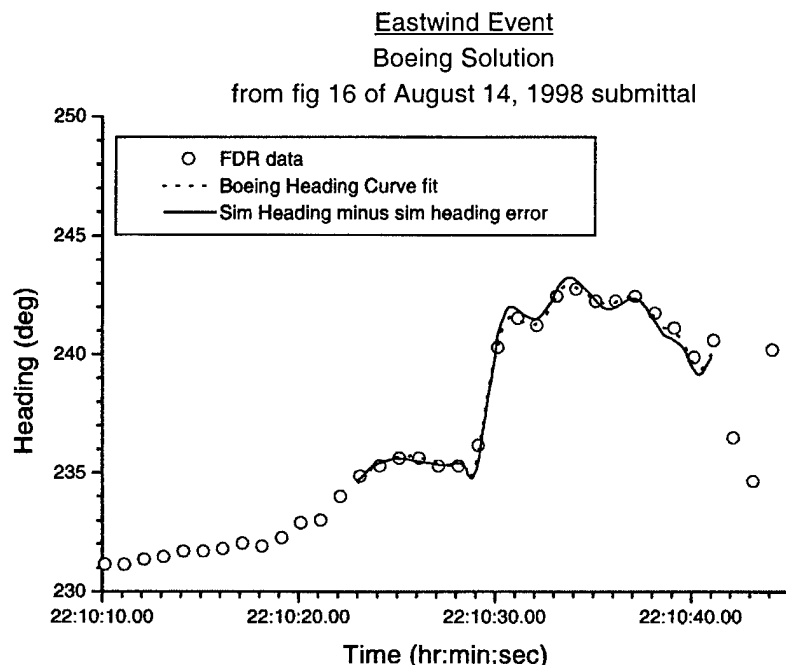
Figure 28a presents the rudder time history that resulted from Boeing's kinematic analysis of scenario 4. The heading time history that Boeing derived from its kinematically developed rudder (uncorrected for what Boeing has determined to be a simulator heading error) and used in its computer simulations is shown in figure 28b. Figure 28c shows the average flight test heading error, and 28d presents the "error corrected" heading time history compared with the FDR heading data.

Figure 28d. Eastwind flight 517 corrected heading according to Boeing's scenario.

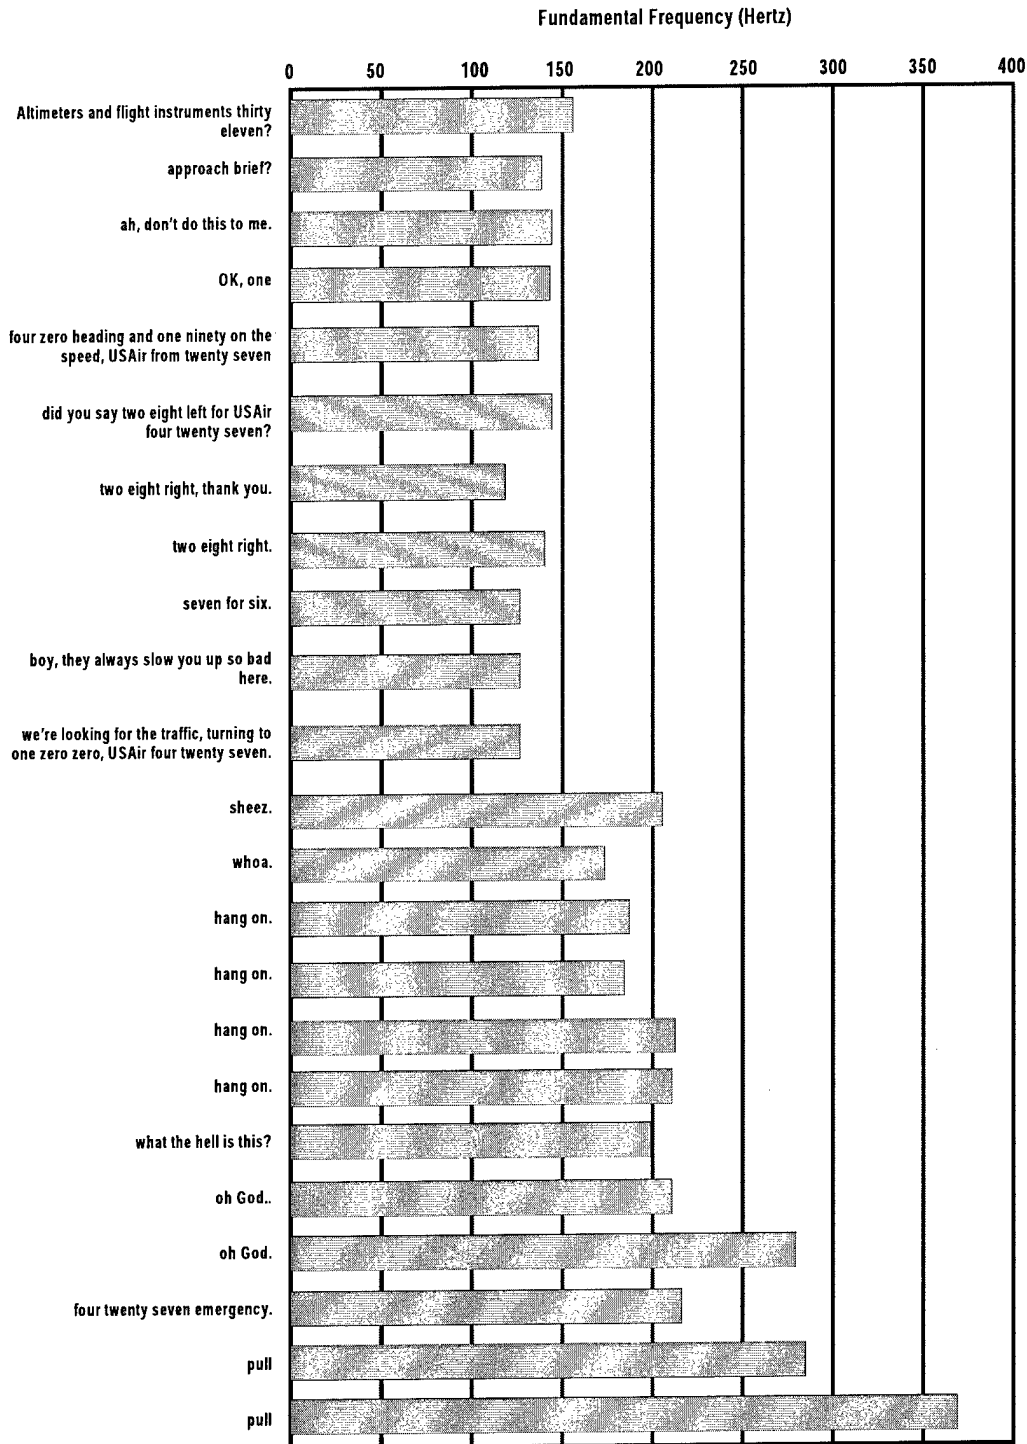
²¹⁰ Only those statements that were free of artifacts caused by background conversation or other sounds appear on this graph and the one in figure 30. Of the three measured aspects of the captain's speech, fundamental frequency provided the most measurable data. Missing data precluded similar measurements of the captain's speech rate or amplitude.

Figure 29. Fundamental frequency measures of the USAir flight 427 captain's speech.

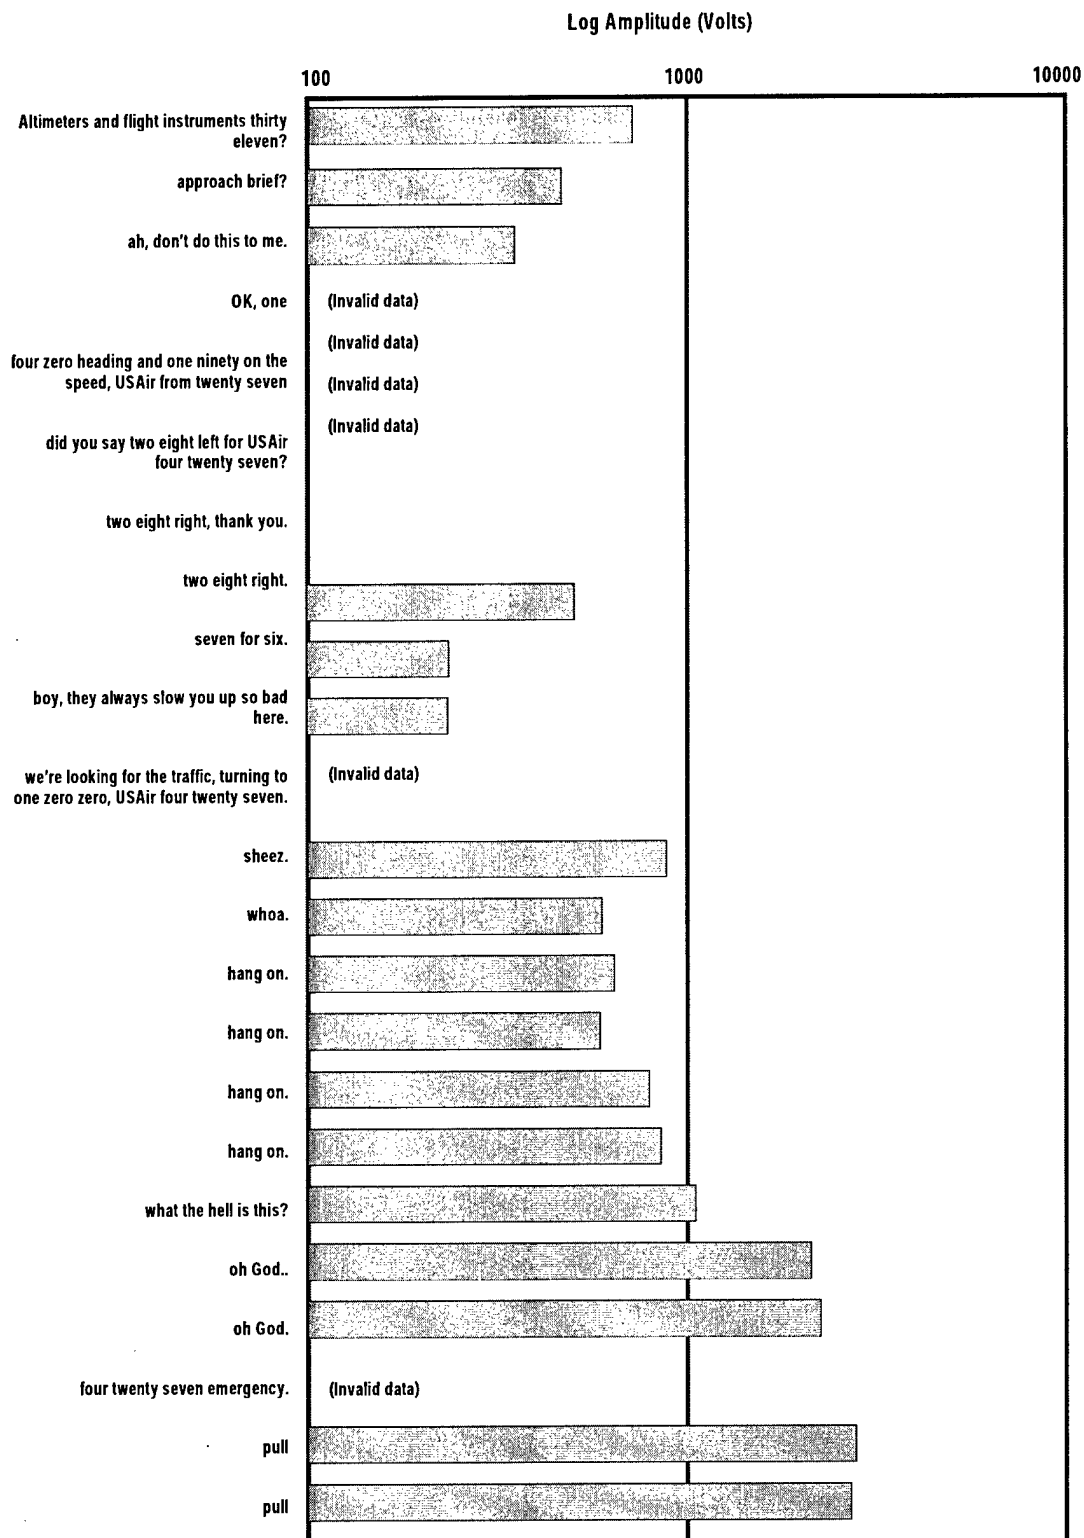
²¹² Amplitude is often measured in decibels, a logarithmic scale determined relative to an internationally accepted calibration standard. Because no calibration standard was available in the CVR recording, amplitude was measured in volts (the direct measure of physical intensity) and plotted on a logarithmic scale for convenience.

Figure 30. Amplitude measures for the USAir flight 427 captain's speech.

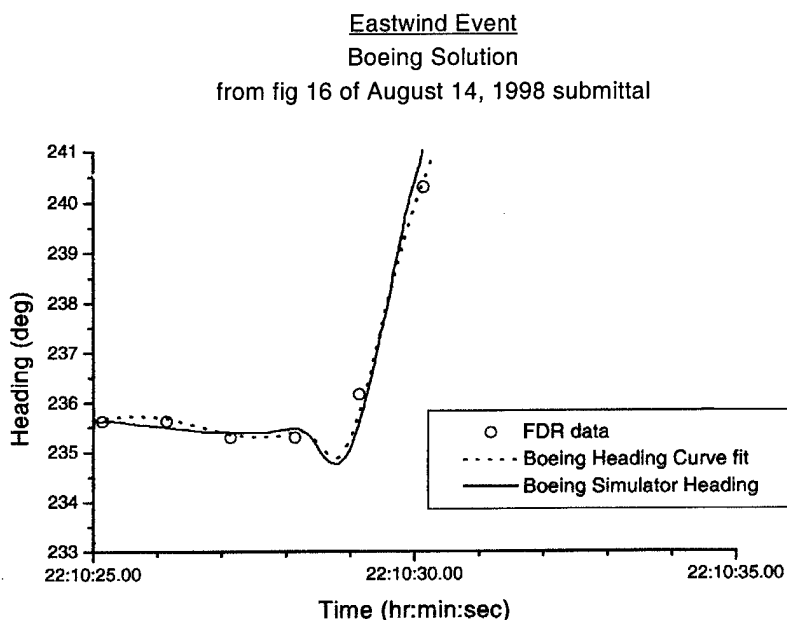
Boeing used its kinematic analysis to derive flight control surface position time histories (particularly the rudder position time history). This effort required Boeing to curve fit the once-per-second FDR heading data, which Boeing accomplished with a manual, nonlinear fit of the heading data, as shown in figure 32. To justify a right rudder

input by the pilot about 2210:29, Boeing introduced a left heading change between 2210:28 and 2210:29 (in response to the postulated left rudder movement from the release of the yaw damper hardover about 2210:28) through its manual nonlinear curve fit of the FDR heading data, even though the FDR data did not reflect a left heading change. (Further, both the flight crew and the lead flight attendant recalled a yaw to the right as the initiating event.). When this manual curve fit of the heading data was used in Boeing's kinematic analysis, the results indicated a left rudder movement about 2210:28 that was consistent with Boeing's scenario of the release of the yaw damper hardover at that time. Boeing then used this rudder surface time history (and other control surface time histories) as input data in its computer simulation to produce airplane motion parameters, including heading.

Figure 32. Boeing's curve fit of the FDR heading data from Eastwind flight 517.

Boeing asserted that its analysis demonstrated rudder activity during the event, which it considered evidence of the yaw damper activity during the event (and therefore evidence that the rudder was not jammed and did not reverse). However, the basis for this assertion that the yaw damper was active during the event is the rudder activity resulting from Boeing's kinematic analysis, which in turn resulted from Boeing's manual, nonlinear curve fit of the FDR heading data. Although the Safety Board cannot prove that the left heading change introduced into Boeing's curve fit about 2210:28 did not exist, no evidence indicates that it did. Further, the heading change does not match the character of the heading data between about 2210:27 and about 2210:30.
